LABORATORY SERVICES REPORT

N1171191.0001

Chemtec One Testing 611 Lunken Park Dr. Cincinnati, OH 45226

Table II Scaling Resistance of Concrete Surfaces Exposed to Deicing Chemicals (ASTM C672-12, Modified to 100 Days)

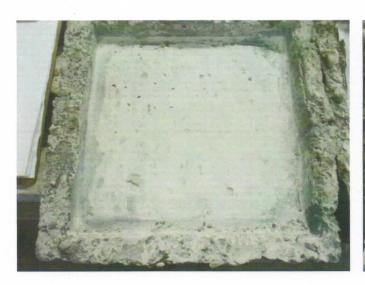
Photo 1: Left photo shows Sample 1 treated with ChemTec ONE solution and right photo shows Sample 1 untreated after 100 Freeze-Thaw cycles. Note severe deterioration of the untreated sample and nearly complete surface loss.

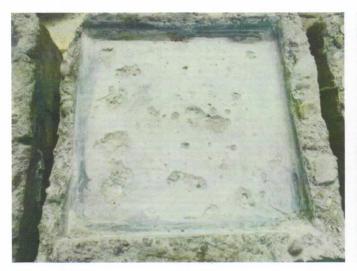
Photo 2: Left photo shows Sample 2 treated with ChemTec ONE solution and right photo shows Sample 2 untreated after 100 Freeze-Thaw cycles. Note severe deterioration of the non-treated sample and complete surface loss.

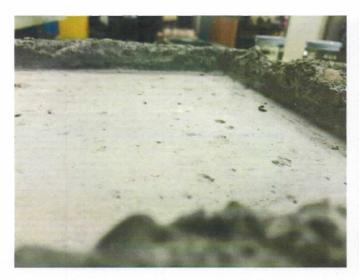
Photo 3: Close-up showing Sample 1 treated with ChemTec ONE solution (left photograph) and Sample 1 untreated (right photograph) after 100 Freeze-Thaw cycles. Note severe deterioration of non-treated sample and protruding coarse aggregate.

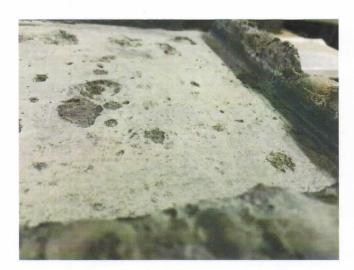
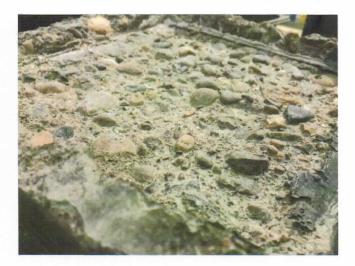
Photo 4: Close-up showing Sample 2 treated with ChemTec ONE solution (left photograph) and Sample 2 untreated (right photograph) after 100 Freeze-Thaw cycles. Note severe deterioration of non-treated sample and protruding coarse aggregate.
